TS-PIC-20105579S
July 2001

HISTORICAL AERIAL PHOTOGRAPHIC ANALYSIS LOCKFORMER SITE Lisle, Illinois

HISTORICAL AERIAL PHOTOGRAPHIC ANALYSIS
LOCKFORMER SITE

Lisle, Illinois

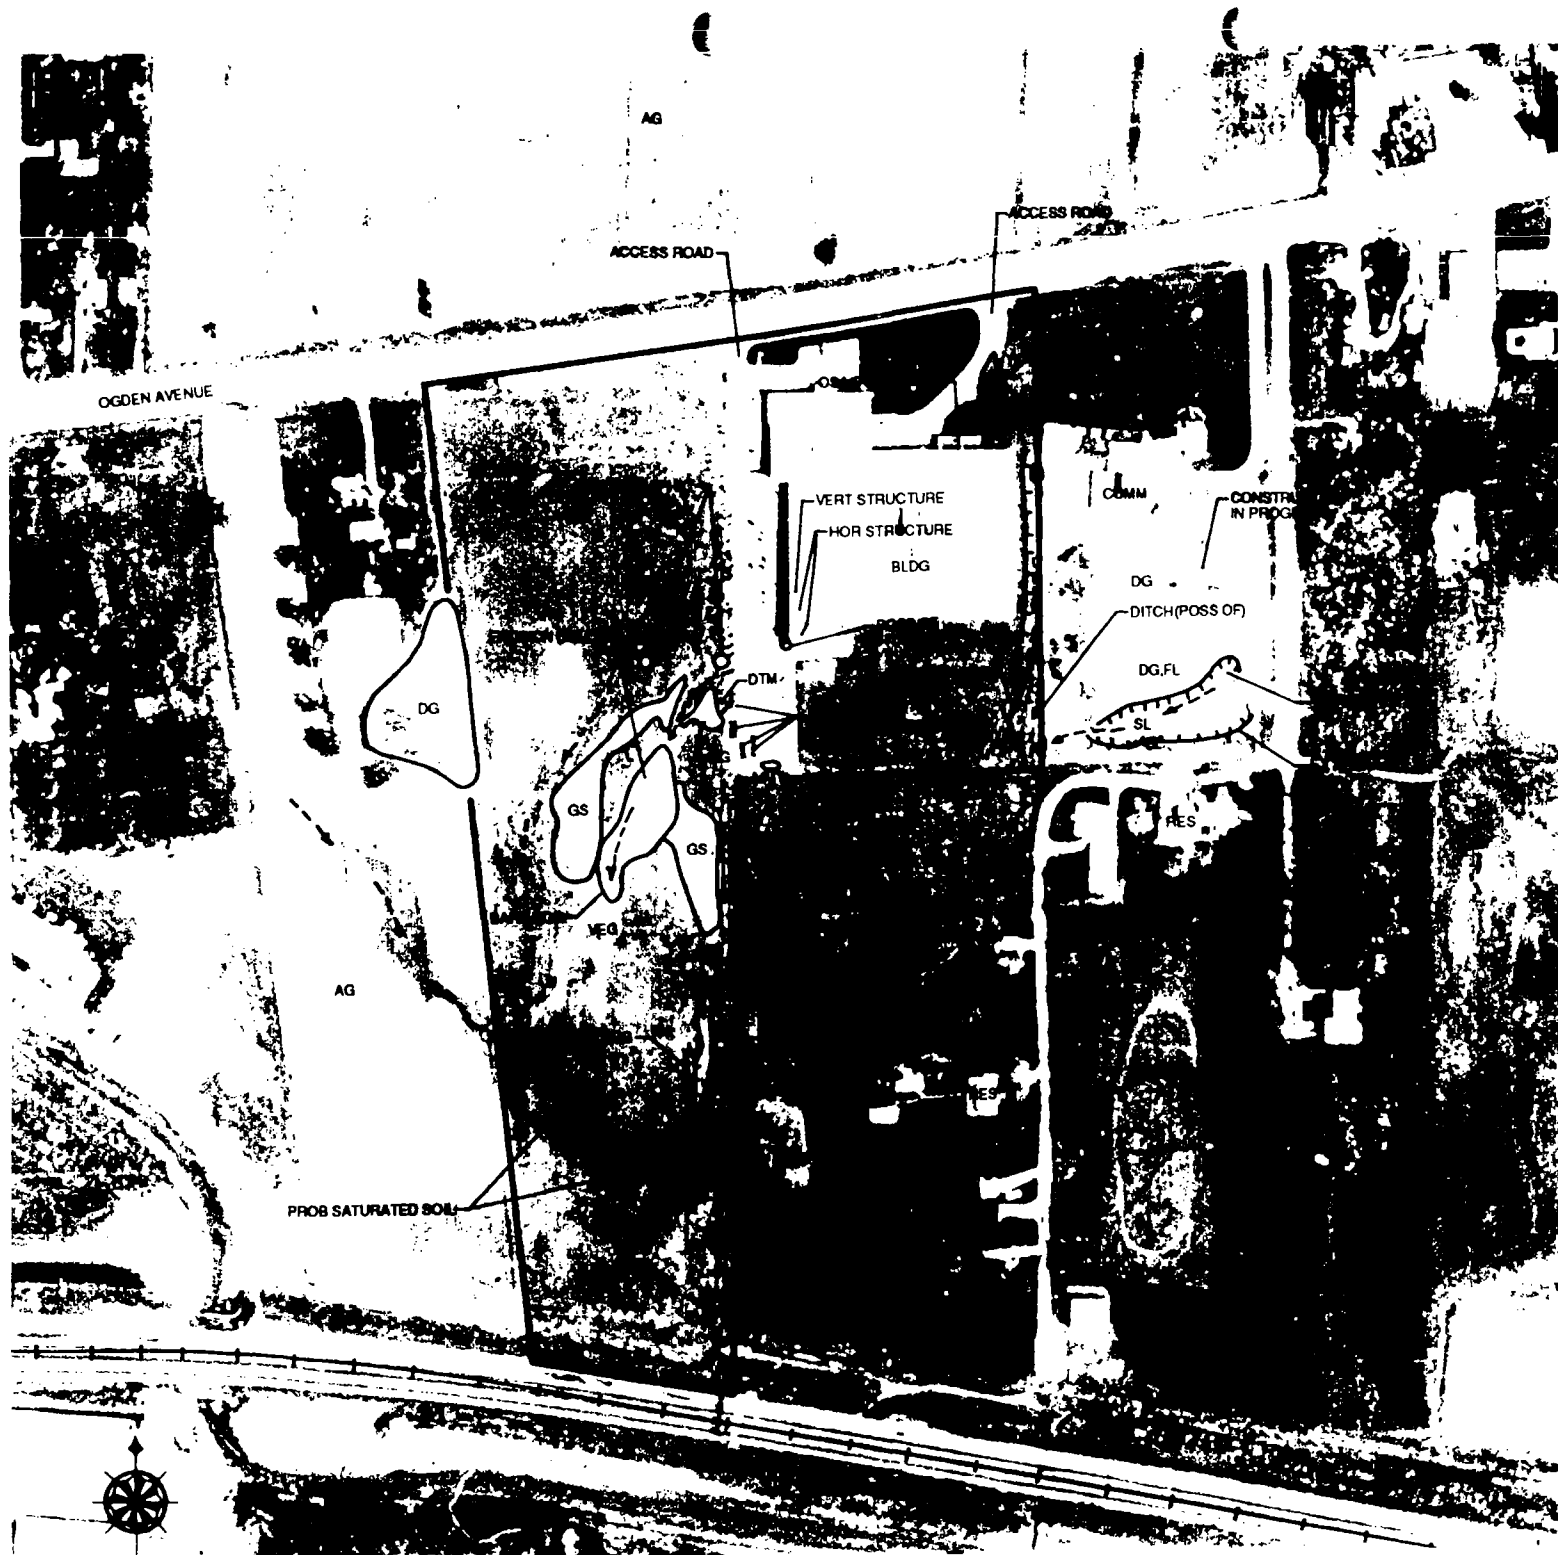
APRIL 23, 1973 (FIGURE 5)

The Lockformer site remains active as numerous cars (not annotated) are present in the parking lot (not annotated) on the west side of the building. On the north side of the building, a stain extends northward from a loading dock, and possible containers (CONT) are observed in the open storage area. Located on the roof of the building near the southwestern corner are the vertical and horizontal structures, and a new, taller, horizontal structure. A possible stain is seen on the ground surface of the parking lot below these structures.

In the southern section of the parking lot are four dark, rectangular-shaped objects. These objects are flat and vary in size; two are approximately 5.5 meters (18 feet) long by 3 meters (10 feet) wide, the other two are about the same length, but are only about 2 meters (6 feet) wide. A possible stain and an adjoining, small drainage gully (annotated by the drainage arrow) are observed just to the southeast of these rectangular objects. In the vegetated field west of these objects, there is a small patch of dark-toned material and disturbed ground. In addition, the area of bare soil which contains numerous erosion gullies, and the two large ground scars remain visible. Smaller erosion gullies are also seen extending southwest from the parking lot. A smaller ground scar, perhaps associated with the forces of overland runoff, and the mounded material, possibly covered with vegetation are noted in the southern portion of the field.

The two well-defined drainage ditches and possible outfalls remain visible on site. The easternmost ditch joins an off-site drainage network to the south. A small ground scar is visible just west of the possible outfall. This ditch carries liquid southwest in close proximity to residential homes. Liquid from this ditch appears to pool in the probably saturated southern section of the vegetated field where runoff from the westernmost ditch and the agricultural land to the west also appears to collect. It is still not possible to determine which direction runoff from the railroad flows.

A large area of disturbed ground is visible along the western site boundary and extends off-site. This area of disturbed ground is probably associated with the residential home to the north. To the east of the site, and south of the commercial establishment, construction is in progress. The impoundment is no longer present and fill has been placed in the former location of the excavated area seen in 1970. However, more excavation activity is visible and the ground surface in many places remains disturbed. Within this new excavated area, saturated soil and standing liquid are evident. A pathway is present which allows this liquid to flow westward out of the excavated area and into the easternmost drainage ditch.

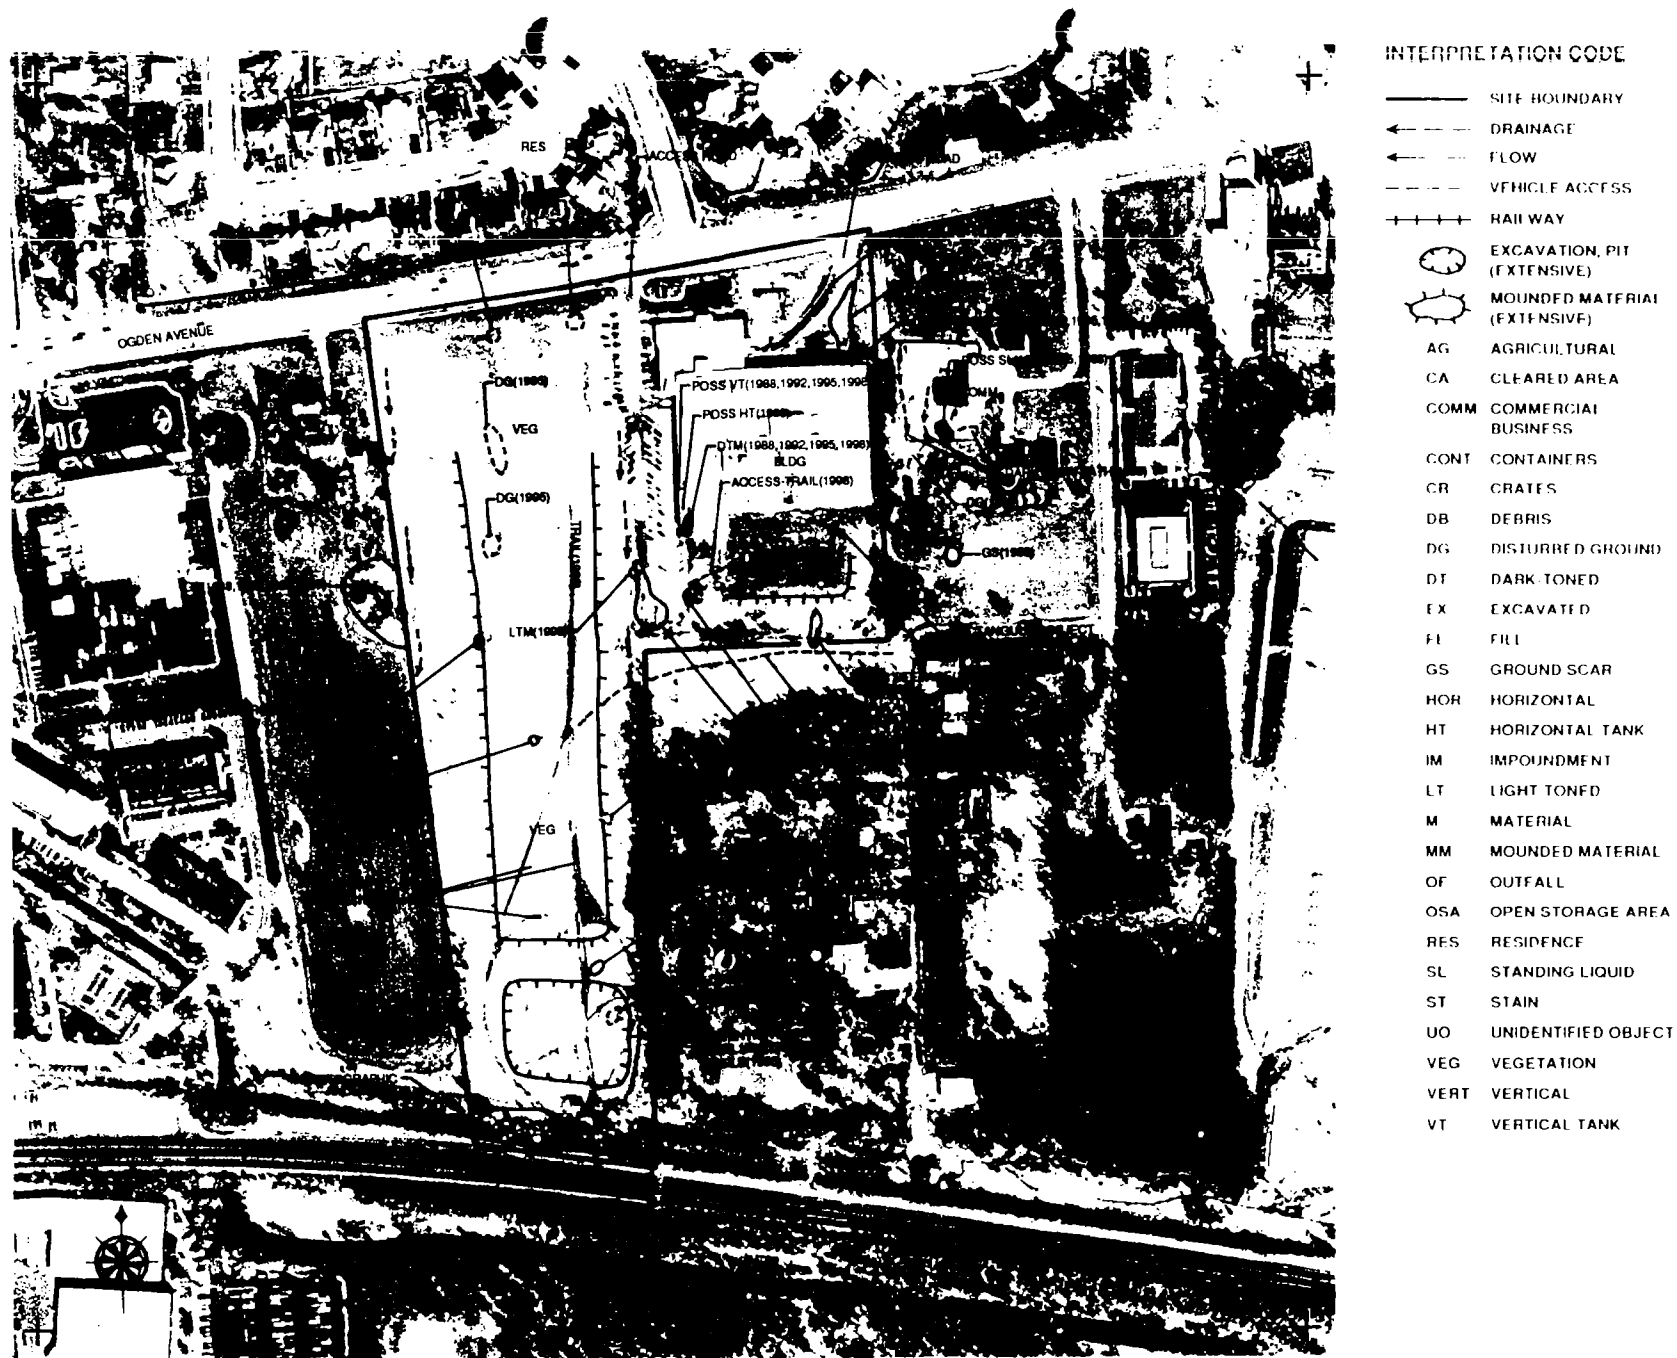
Figure 11. Lockformer site, March 24, 1998. Approximate scale 1:2,890.

The Lockformer site remains active and numerous cars (not annotated) are visible on the parking lot (not annotated). On the north side of the building, a stain (1988, 1992, 1995, and 1998) extends from the loading dock northward almost to Ogden Avenue, and a flow path (1995 and 1998) is visible. On the southwestern corner of the building roof, are the possible vertical storage tank (1988, 1992, 1995, and 1998) and the dark-toned material (1988, 1992, 1995, and 1998). The possible horizontal storage tank was last observed in 1988. At the southern end of the parking lot, a possible stain (1988, 1992, 1995, and 1998) and a small patch of light-toned mounded material (1998) are observed. To the east of the possible stain is a possible refuse container (1998).

The mound (1988, 1992, 1995, and 1998) and vegetated cover remain visible south of the building. An area of disturbed ground (1998) is visible on the top of the mound. On the north side of the mound by the building is a compact, rectangular-shaped object, and on the south side of this mound is possible seepage (1998). A ground scar was observed at this location in 1988.

The mound (1988, 1992, 1995, and 1998) and vegetated cover remains on the western portion of the site. In the northern section of the mound, adjacent to the parking lot, a small ground scar was observed in 1988. Numerous areas of disturbed ground were identified on the mound in 1995 and 1998; one of these areas located near the western slope appeared to be a probable pit. South of this mound is an area of light-toned material (1998) and the retention basin (1988, 1992, 1995, and 1998). In 1995 an unidentified object (UO) and dark-toned material were observed within this basin. Runoff from the site continues to be channeled toward this basin, but no liquid is observed. Southeast of the basin near the railroad is an area of disturbed ground and possible dark-toned material (1998). Numerous trails (1995 and 1998) and an access road (1992, 1995, and 1998) traverse the western mound and retention basin.

A ground scar (1988, 1992, 1995, and 1998) is visible on the agricultural land west of the site. To the east of the site, disturbed ground was seen in 1988 and a ground scar was visible in 1998. Possible standing liquid was observed in 1992, 1995, and 1998. Dark flow paths were discernible in 1998; one of these connected to the possible standing liquid. The area north of the site has been completely developed.
